Trinity Episcopal Church

Groton, South Dakota

Stained Glass Repair
January 2016

Prepared for the
Brown County Historical Society
By Betty Breck
PO Box 441
Groton, SD 57445
(941) 525-4515

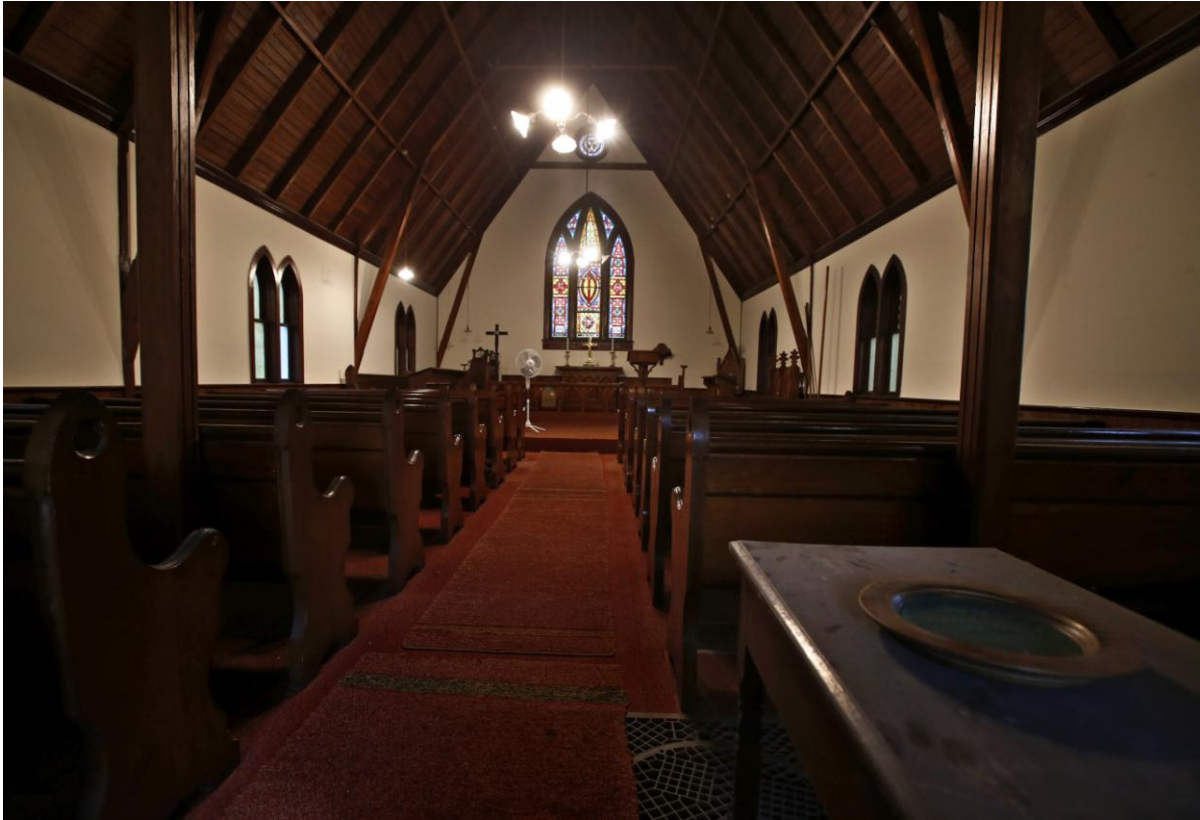
The focal feature of this building is a large stained and painted glass arched window with wooden tracery that creates three lancet shapes behind the altar. The small lancet windows on the sides and in the vestibule are not part of the current grant proposal.

The purpose of this study is to assess the damage to the 130-year-old window and provide a solution to return it to its former glory. The repairs recommended in this report will respect the historic character of the building and, more importantly, the ornate window itself. The following needs have been identified:

1. The outer plexiglass needs to be removed and replaced with glass.
2. The stained and painted glass windows themselves need to be disassembled and re-ledged back together.
3. Some individual pieces of stained and painted glass will need to be repaired or replaced.
4. Structural members between the stained glass will need to be examined and replaced as needed.
5. The exterior window trim needs to be repainted.

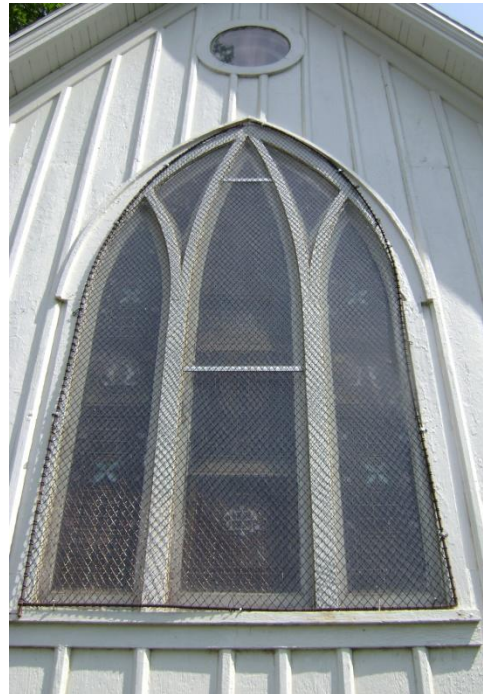
The windows suffered extensive damage at the hands of vandals during the time the church was not being used or supervised by the Episcopal Diocese until it was deeded to the Brown County Historical Society. Baseballs thrown through the small lancet windows broke almost two-thirds of them. These are now filled with plain opaque glass.

A metal grill on the outside of the big altar window saved it from destruction by baseballs, but it was not immune to shots fired from BB guns. It has numerous holes and cracks which will require replacement of pieces of stained and painted glass.

To protect the windows, the Brown County Historical Society removed the metal grill from the large altar window, covered all the windows with plexiglass, and re-installed the metal grill. No further damage to the windows or to the church itself has occurred since it came under the supervision of the Brown County Historical Society.

Despite the extensive vandal damage, the most pressing reason for repairing the 130-year-old windows now is the weight bowing and bulging due to aging lead. This grant application seeks funds for the repair of only the large altar window and not the small side windows because the altar window needs immediate attention, whereas the small windows can wait until such time as they can be repaired and replaced as a complete project, funded by the sale of memorial plaques for each window.

The stained and painted glass panels need to be removed, disassembled, and re-leaded. Structural members need attention and reinforcing where deficient. Exterior protective plexiglass needs to be removed and replaced by clear vented exterior glazing for protection. Exterior woodwork should be re-painted at this time.
