Trinity Episcopal Church

Groton, South Dakota

Stained Glass Repair
January 2016

Prepared for the
Brown County Historical Society
By Betty Breck
PO Box 441
Groton, SD 57445
(941) 525-4515

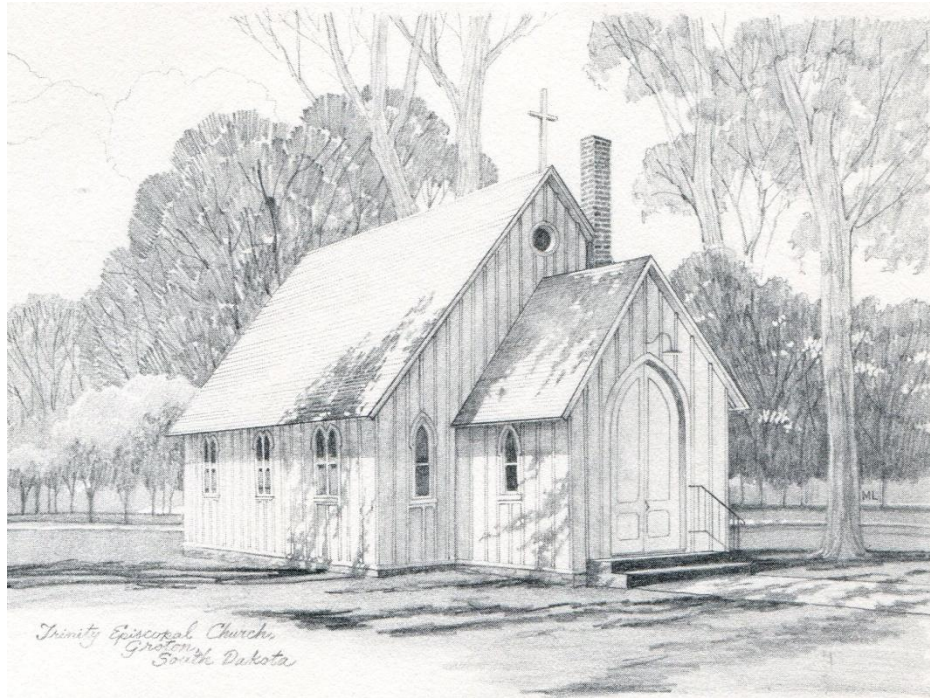
A metal grill on the outside of the big altar window saved it from destruction by baseballs, but it was not immune to shots fired from BB guns. It has numerous holes and cracks which will require replacement of pieces of stained and painted glass.

Despite the extensive vandal damage, the most pressing reason for repairing the 130-year-old windows now is the weight bowing and bulging due to aging lead. This grant application seeks funds for the repair of only the large altar window and not the small side windows because the altar window needs immediate attention, whereas the small windows can wait until such time as they can be repaired and replaced as a complete project, funded by the sale of memorial plaques for each window.

- *Remove exterior plexiglass and metal grill
- *Remove large altar window
- *Determine if plexiglass can protect holes sufficiently while windows are out and re-install it and grill, OR
- *Seal opening with wood to protect during restoration
- *Clean, disassemble and re-lead glass, replacing pieces as needed
- *Repair or replace structural members as needed
- *Re-install restored window
- *Install clear exterior protective vented glass with custom aluminum frames
- *Paint and finish. Re-install metal grill.
